AFFDL-TR-76-54

**LABORATORY TEST AND EVALUATION OF A  
GRAPHITE EPOXY AIRCRAFT WHEEL**

TECHNICAL REPORT AFFDL-TR-76-54  
FINAL REPORT FOR PERIOD JULY 1972 - JULY 1975

AIR FORCE FLIGHT DYNAMICS LABORATORY  
AIR FORCE WRIGHT AERONAUTICAL LABORATORIES  
AIR FORCE SYSTEMS COMMAND  
WRIGHT-PATTERSON AIR FORCE BASE, OHIO 45433

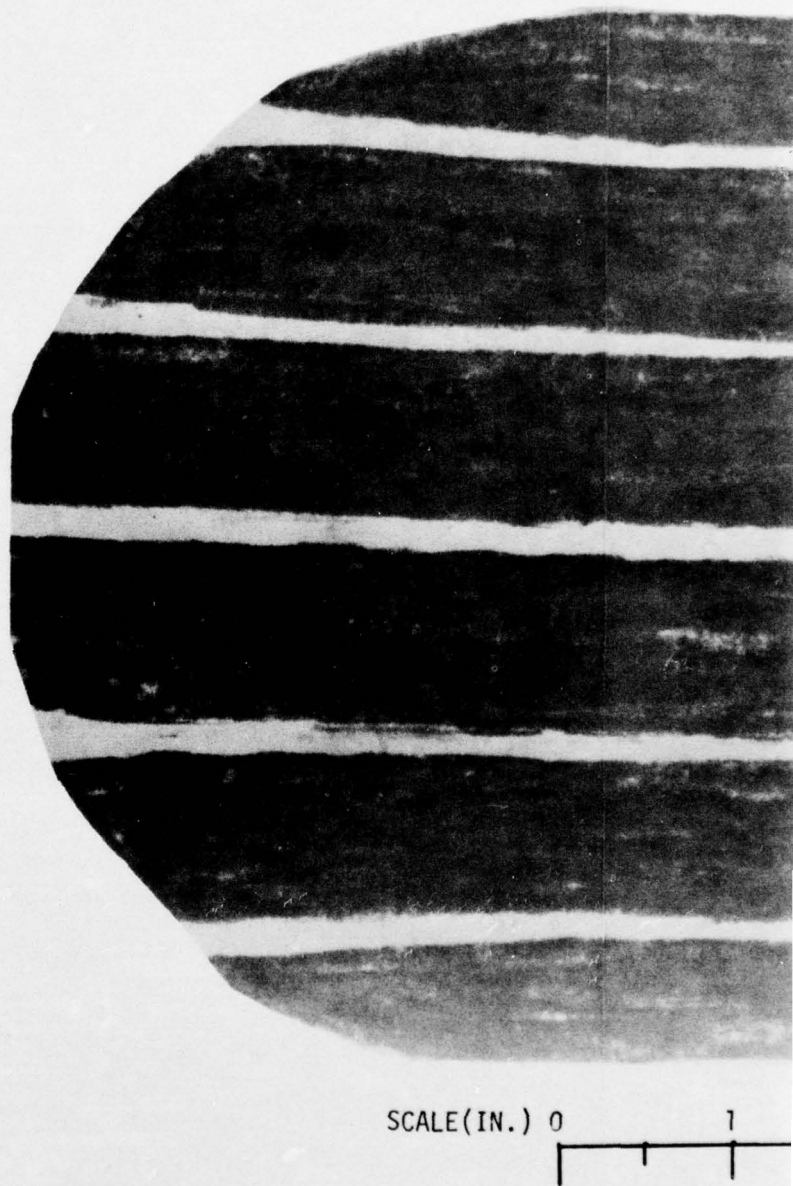
RATED INFLATION .....	120 PSI	MAX. FOOTPRINT LGTH.....	9.875 IN.
.....% RATED LOAD .....	6150 LBS.	MAX. FOOTPRINT WDT.....	5.750 IN.
35% DEFLECTION		NET CONTACT AREA .....	42.33 SQ.IN.
		GROSS CONTACT AREA.....	48.56 SQ.IN.

Figure 17. Footprint of the Tire on a Flat Pla

level was assumed to be conservative for a composite structure. No audible noises were emitted from the structure during the static loading. The flat plate static tests were done primarily to verify that the wheel would withstand the rated loads prior to the instrumentation modifications necessary for dynamometer slow roll tests. Flat plate deflection measurements were also made on the test rig of Figure 16. These measurements indicated the tire was deflected 35% under the rated load, a condition that is identical to the metal wheel under similar conditions. A footprint of the tire on the flat plate under rated load was also taken and this is shown in Figure 17.

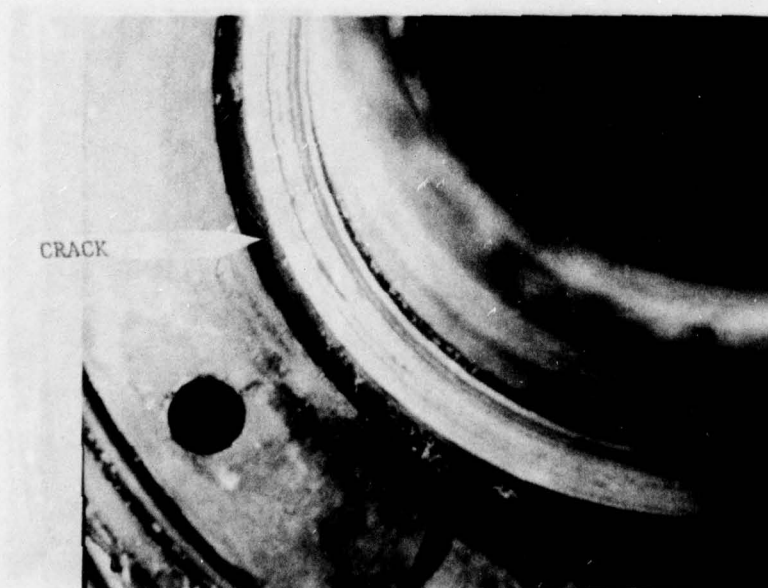
Figure 23. Crack in Composite Near AL Hub

At 260 miles into the straight slow roll test, several events occurred which delayed the tests. During a visual inspection of the wheel, crazing lines were discovered in the outer flange area near the bead seat. At this point the test was stopped and the wheel was disassembled. Figure 22 illustrates the wheel immediately after disassembly. A crack was discovered in the composite structure near the Al hub and this is shown in Figure 23.

This crack appeared to extend over approximately 120° of the circumference. Figure 23 also shows what appears to be graphite epoxy "chips" or shavings in the cavity near the base of the Al hub. Figure 24 shows the graphite epoxy shavings on the opposite wheel half. This figure also shows what appears to be a wear area on this wheel half. The Al hub (Figure 22) also was showing signs of wear. The explanation for the wear which occurred between the Al hub and the composite structure will be discussed in subsequent paragraphs.

At this point all efforts focused on determining the severity of the crack near the Al hub. The hub was firmly attached to the wheel and could not easily be removed, so this naturally hindered the inspection. The nondestructive test (NDT) inspection most readily available was the X-ray process. Low energy X-ray radiation techniques were attempted but the complex shape of the region near the crack precluded its detection.

The crack was thoroughly examined under a stereo microscope with a magnification up to 50X. The depth of the crack could not be determined but the crack appeared to turn inward toward the hub. This crack did grow into a delamination which will be discussed later in the 1,000 mile inspection.

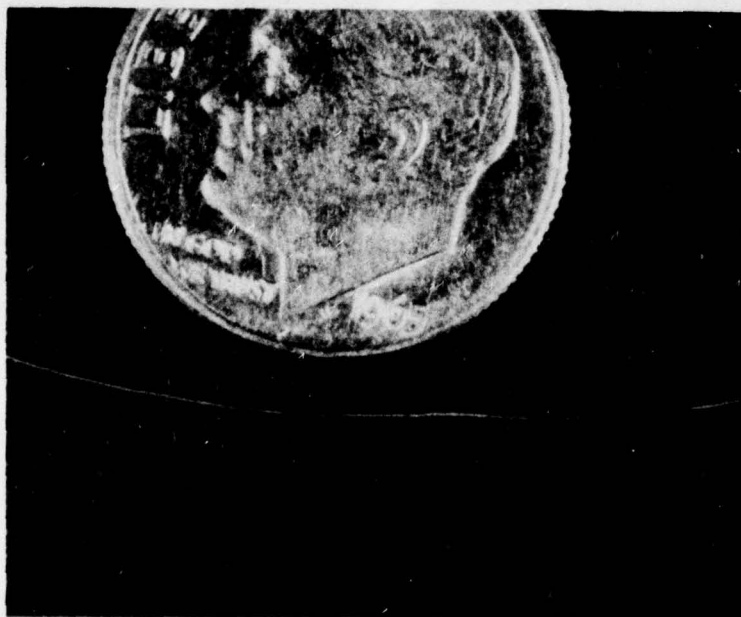
Figure 25. Section 1 of Crack and Scaling Objects

In Figure 25 a dime and a 0.010 in. wire are shown for scale factor purposes. Based on this photograph, the pictures of the crack are a 4X representation of the actual part. The entire length of the crack was split up into eleven segments and overlapping photographs were taken. These pictures are shown in Figures 25 through 28.

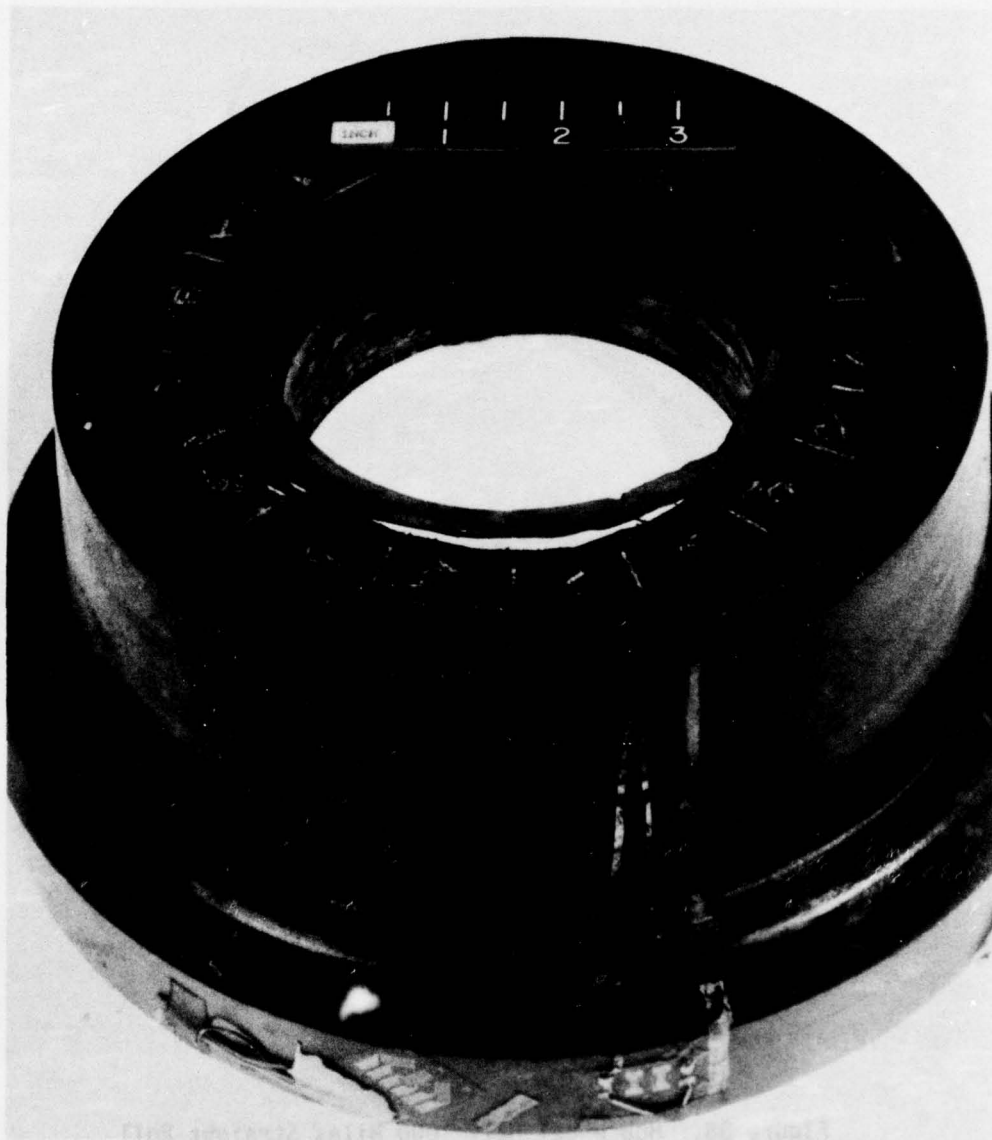
Figure 37. Hub Wheel Half 1000 Miles Straight Roll

The roll test was uneventful from 650 to 1000 miles of straight roll. After 1000 miles, as the wheel was disassembled for inspection, the Al hub had moved axially and could finally be forced from the wheel. Figures 37 through 42 depict the wheel after 1000 miles of dynamometer straight roll. At this time the crack discovered at 650 miles had developed into definite corner delamination. As shown, this delamination extended over halfway around the circumference of the wheel. Since this delamination extended over halfway around the circumference of the wheel. Since this delamination did not extend into the hub of the wheel its effects on the structure of the wheel were negligible. Figures 37 through 42 also illustrate the condition of the bolt bosses, the wheel hub, bead seat, and the Al hub after 1000 mile of slow roll. All of the wear which resulted from the rubbing of the Al hub on the G/E wheel half was confined to the hub.

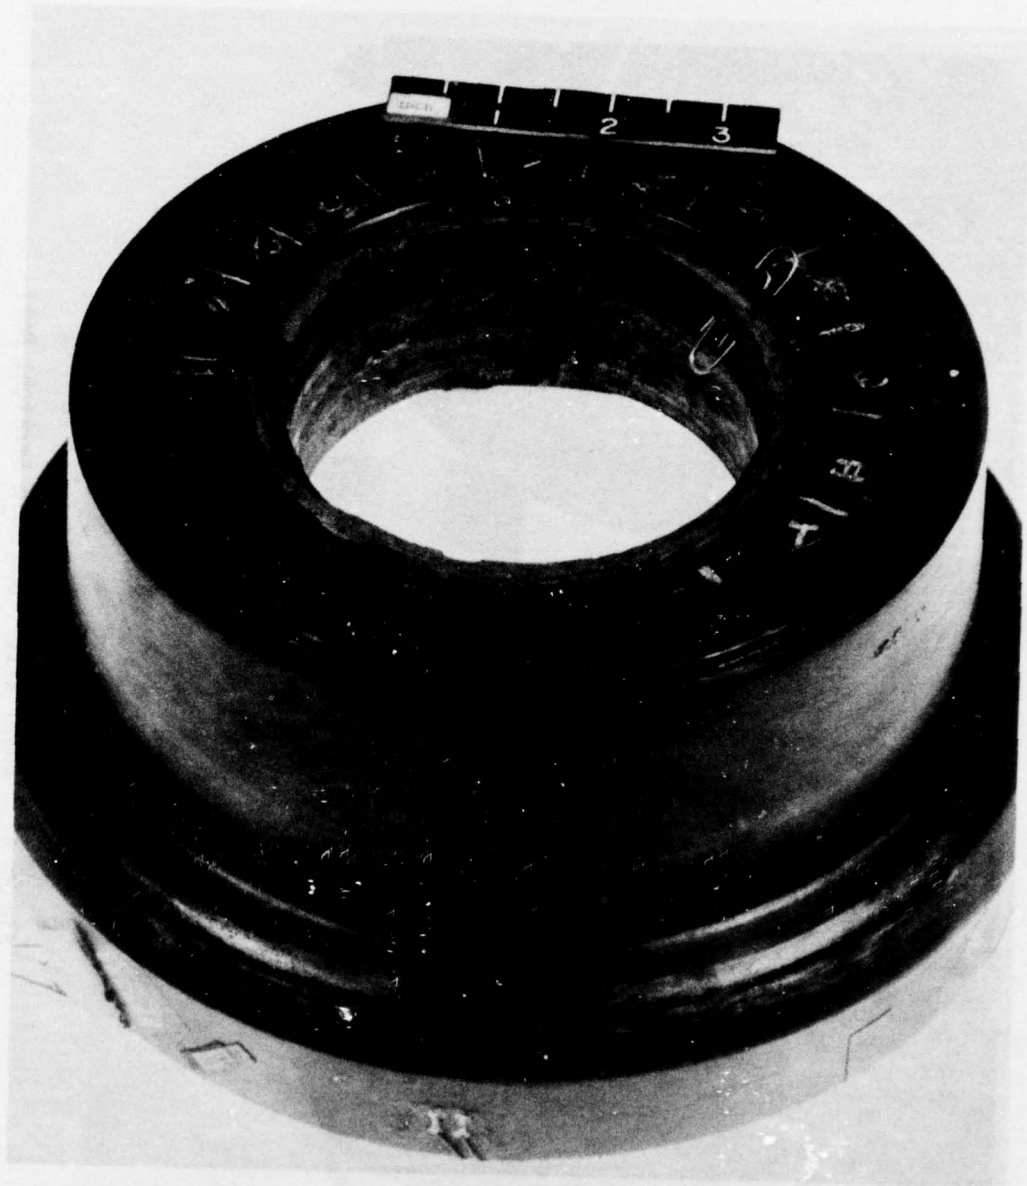
Figure 41. Hub Wheel Half 1000 Mile Straight Roll
